**Flood Control Project Maintenance
Levee Inspections****LMA District Cover Sheet****Spring 2013 Levee Inspection Results****Reclamation District No. 0817 Carlin**

Levee Inspection Report By Mile - Spring 2013

Reclamation District No. 0817 Carlin

Waterway				Bank	Unit Miles	Inspection Start/End	Inspector
Unit No. 01 South Dry Creek				Left	3.82	04/30/2013 04/30/2013	Rick Burnett

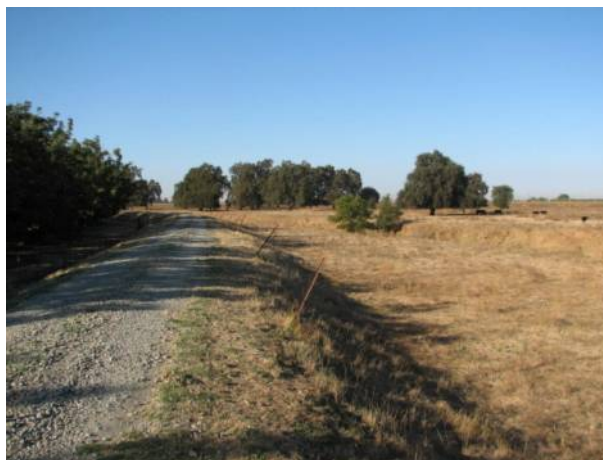
Levee Mile Report Line	4
Start Levee Mile	0.01
End Levee Mile	0.60
Location	Water Side
Category	
Item	Vegetation

Levee mile 3.80, the waterside slope.

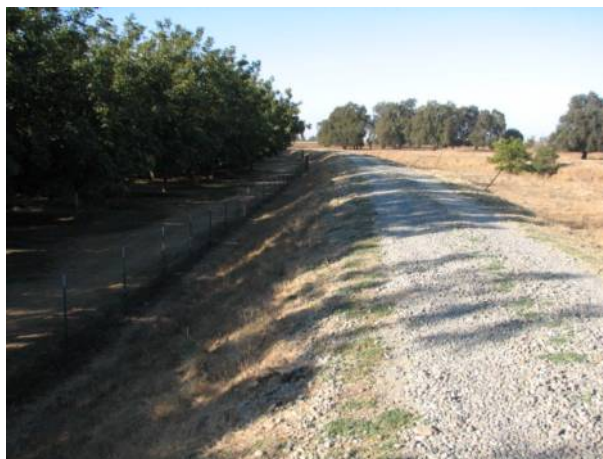
Levee Mile Report Line	5
Start Levee Mile	0.01
End Levee Mile	0.60
Location	Land Side
Category	
Item	Vegetation

Levee mile 3.80, the landside slope.

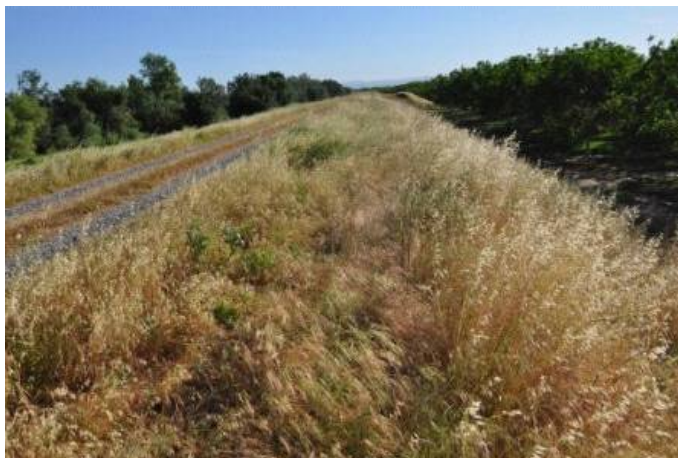
Levee Mile Report Line	6
Start Levee Mile	0.01
End Levee Mile	3.81
Location	Land Side
Category	
Item	Vegetation

Typical L/S levee slope vegetation.

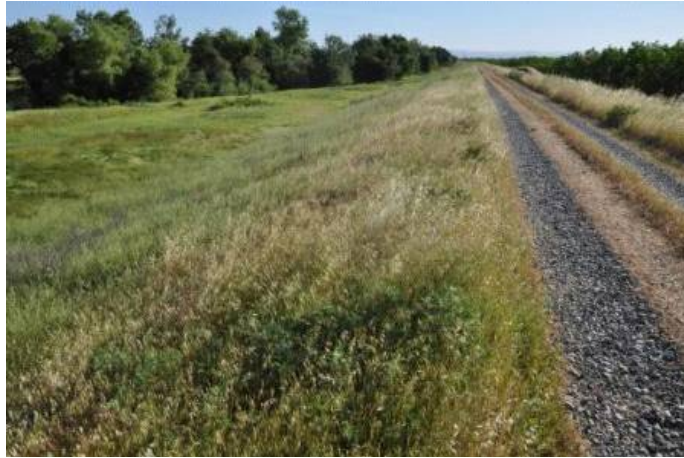
Levee Mile Report Line	7
Start Levee Mile	0.01
End Levee Mile	3.81
Location	Water Side
Category	
Item	Vegetation

Typical W/S levee slope vegetation.

DWR ID: DWR_RD0817_01_s_2013_1										
7	0.01	3.81		Vegetation	WS	M Ma	V1 : Control annual grass and weeds on the levee slopes and easements.	38.984827 ° -121.506082 °	39.019761 ° -121.454147 °	4 Y
DWR ID: DWR_RD0817_01_s_2013_4										
8	1.34	1.34		Encroachments	LS	U En	PI : Pipe	38.997916 ° -121.488499 °	38.997916 ° -121.488499 °	7 Y
DWR ID: DWR_RD0817_01_f_2012_7										
9	1.74	3.81		Encroachments	LS	M En	FE : Fence Inspector Comments: Wire fence at L/S levee toe.	39.002941 ° -121.484856 °	39.019763 ° -121.454151 °	8 Y
DWR ID: DWR_RD0817_01_s_2013_8

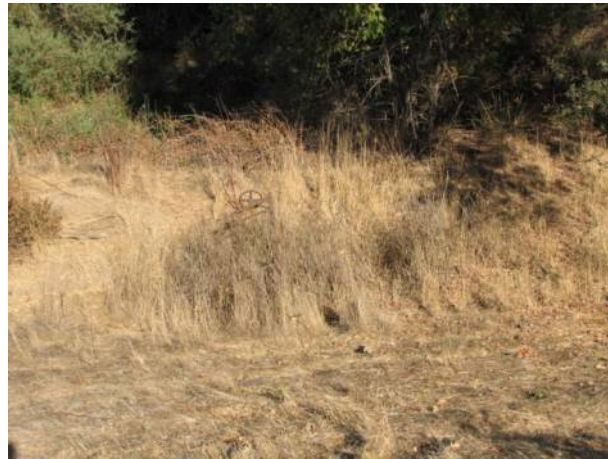
Levee Mile Report Line	8
Start Levee Mile	1.34
End Levee Mile	1.34
Location	Land Side
Category	
Item	Encroachments

This screw gate is not operating properly.

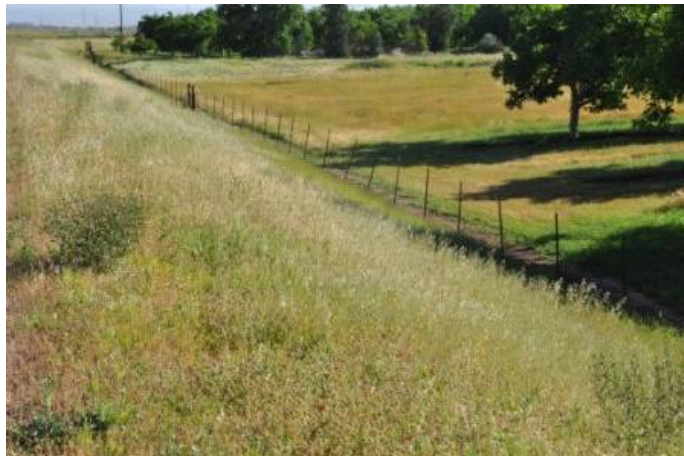
Levee Mile Report Line	9
Start Levee Mile	1.74
End Levee Mile	3.81
Location	Land Side
Category	
Item	Encroachments

Wire fence at L/S levee toe.

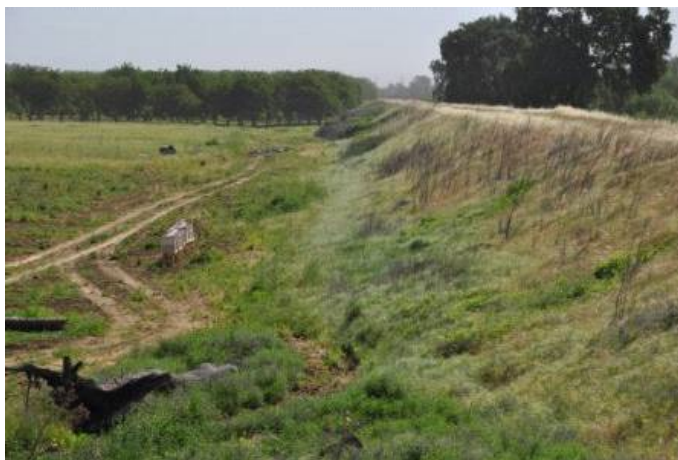
Levee Mile Report Line	1
Start Levee Mile	0.01
End Levee Mile	3.28
Location	Land Side
Category	
Item	Vegetation

Typical seasonal vegetation on L/S levee slope.

LMR No.	Levee Mile		Category	Item	Location	Rating	Action/Comment	GPS Latitude/Longitude		Issue No.
	Start	End						Start	End	Photo
1	0.01	3.28		Vegetation	LS	M Ma	V1 : Control annual grass and weeds on the levee slopes and easements.	38.984569 ° -121.506048 °	38.993865 ° -121.447972 °	8 Y
								DWR ID: DWR_RD0817_02_s_2013_8		
2	0.01	3.84		Vegetation	WS	M Ma	V1 : Control annual grass and weeds on the levee slopes and easements.	38.984569 ° -121.506048 °	38.993178 ° -121.437827 °	9 Y
								DWR ID: DWR_RD0817_02_s_2013_9		
3	0.01	1.00		Vegetation	LS	A Ma	V2 : Remove the wild growth other than native grasses from the levee slopes.	38.984502 ° -121.505957 °	38.983962 ° -121.504625 °	5
								DWR ID: DWR_RD0817_02_f_2012_5		
4	0.01	1.00		Vegetation	WS	A Ma	V2 : Remove the wild growth other than native grasses from the levee slopes.	38.984502 ° -121.505958 °	38.983962 ° -121.504625 °	7
								DWR ID: DWR_RD0817_02_f_2012_7

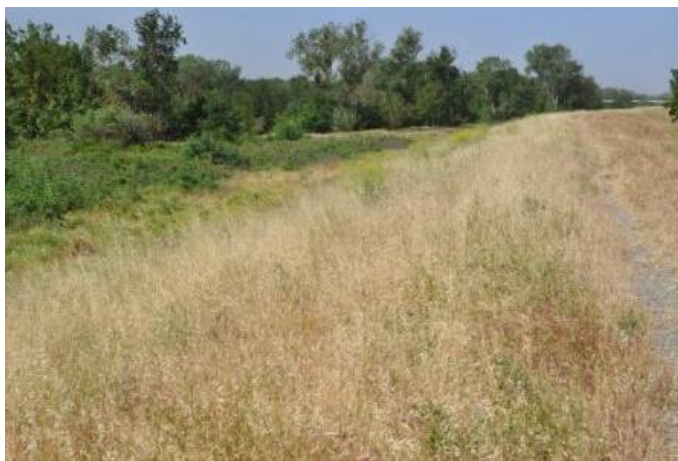
Levee Mile Report Line	2
Start Levee Mile	0.01
End Levee Mile	3.84
Location	Water Side
Category	
Item	Vegetation

Typical W/S seasonal vegetation.

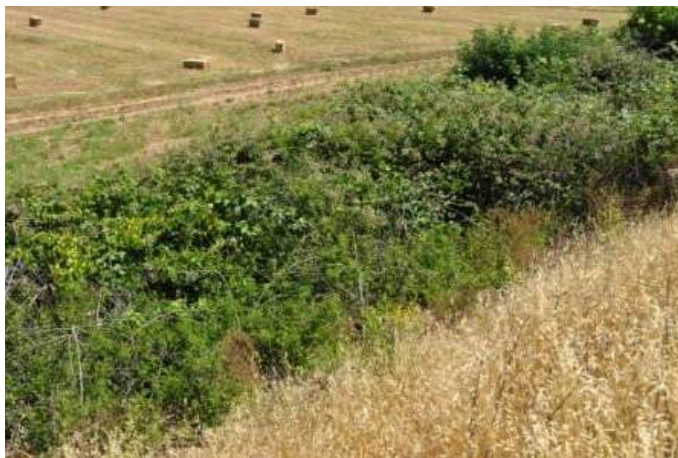
Levee Mile Report Line	5
Start Levee Mile	0.27
End Levee Mile	0.27
Location	Land Side
Category	
Item	Vegetation

5	0.27	0.27		Vegetation	LS	M Ma	V2 : Remove the wild growth other than native grasses from the levee slopes. Inspector Comments: District has sprayed vegetation but dead vines remain in place.	38.984377 ° -121.501553 °	38.984377 ° -121.501553 °	1 Y
								DWR ID: DWR_RD0817_02_s_2012_1		
6	0.32	0.32		Vegetation	LS	M Ma	V2 : Remove the wild growth other than native grasses from the levee slopes. Inspector Comments: District has sprayed vegetation but dead vines remain in place.	38.984467 ° -121.500488 °	38.984467 ° -121.500488 °	2 Y
								DWR ID: DWR_RD0817_02_s_2012_2		
7	0.39	0.39		Vegetation	LS	M Ma	V2 : Remove the wild growth other than native grasses from the levee slopes. Inspector Comments: District has sprayed vegetation but dead vines remain in place.	38.984542 ° -121.499283 °	38.984542 ° -121.499283 °	3 Y
								DWR ID: DWR_RD0817_02_s_2013_3		
8	1.54	1.54		Encroachments	LS	M En	PR : Prunings	38.986864 ° -121.478243 °	38.986864 ° -121.478243 °	11 Y

RD 817 Unit 2 - L/S Vegetation - Blackberries & Wild Rose

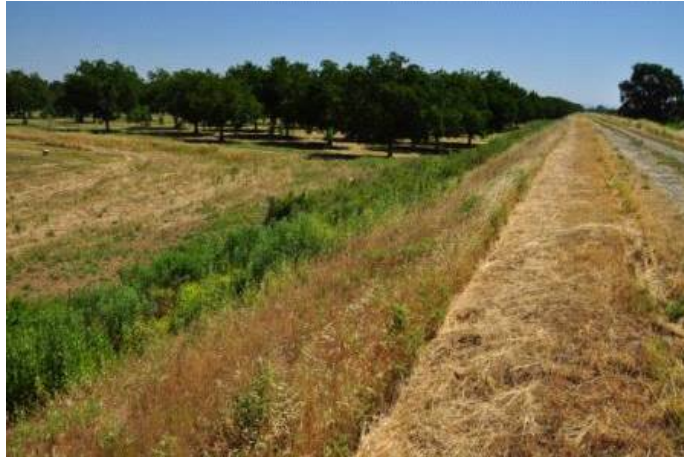
Levee Mile Report Line	6
Start Levee Mile	0.32
End Levee Mile	0.32
Location	Land Side
Category	
Item	Vegetation
RD 817 Unit 2 - L/S Vegetation - Wild Rose	
jhirabay_s_20130314_070.JPG

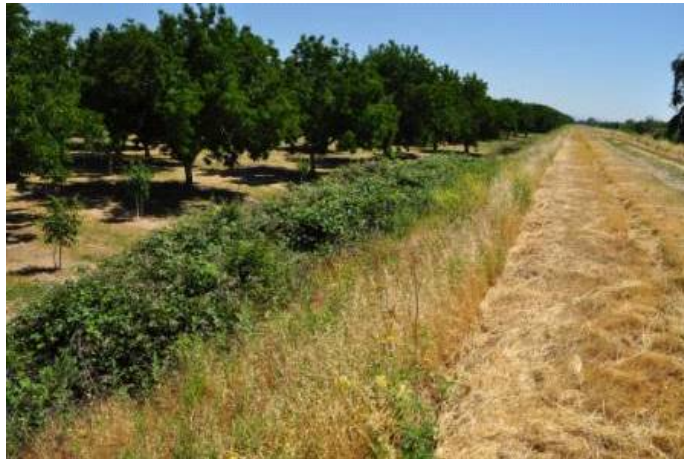
Levee Mile Report Line	7
Start Levee Mile	0.39
End Levee Mile	0.39
Location	Land Side
Category	
Item	Vegetation
RD 817 Unit 2 - L/S Vegetation - Blackberries & Wild Rose	
jhirabay_s_20130314_071.JPG

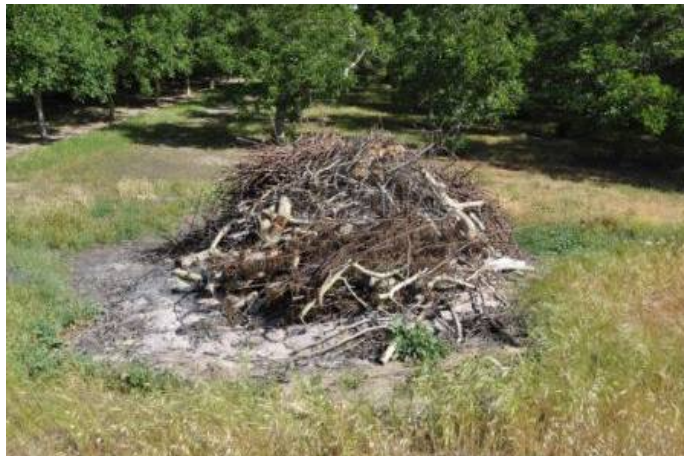
Levee Mile Report Line	8
Start Levee Mile	1.54
End Levee Mile	1.54
Location	Land Side
Category	
Item	Encroachments
Pruning pile at L/S levee toe.	
rburnett_s_20130430_302.JPG

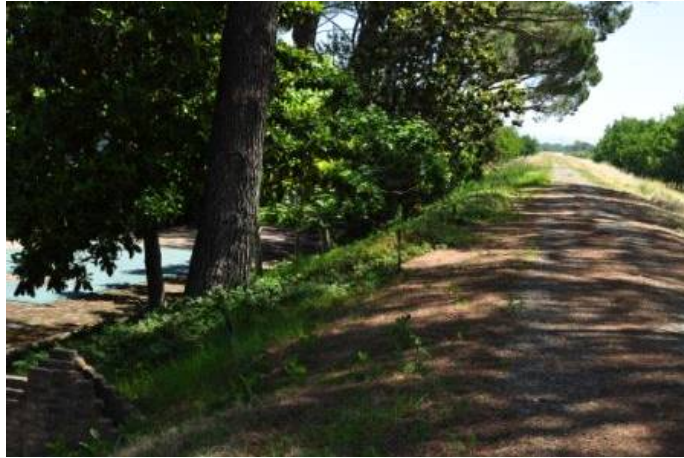
Levee Mile Report Line	9
Start Levee Mile	1.76
End Levee Mile	1.82
Location	Land Side
Category	
Item	Vegetation

RD 817 Unit 2 - L/S Landscaping

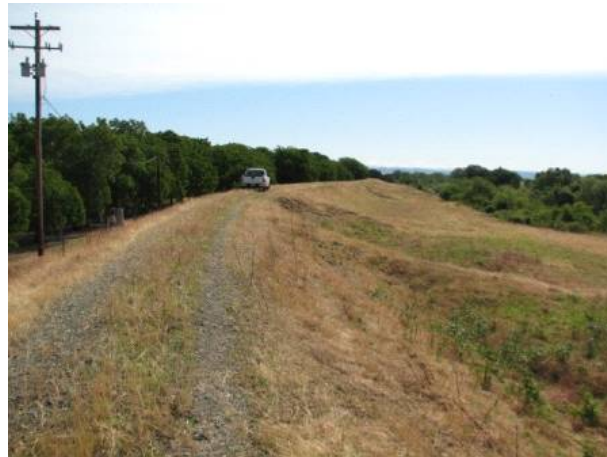
Levee Mile Report Line	10
Start Levee Mile	2.08
End Levee Mile	3.19
Location	Land Side
Category	
Item	Slope Stability

Levee mile 2.08, this photo shows the slope is less than required, this is the downstream limit of the site, this is the waterside slope.

DWR ID: DWR_RD0817_02_s_2013_11		
9	1.76	1.82		Vegetation	LS	M En	V6 : Landscaping	38.987792 ° -121.474295 °	38.988118 ° -121.473372 °	6 Y
								DWR ID: DWR_RD0817_02_s_2012_6		
10	2.08	3.19		Slope Stability	LS	M Ma	S1 : Repair slope instability.	38.989338 ° -121.468640 °	38.994124 ° -121.449448 °	10 Y
								DWR ID: DWR_RD0817_02_s_2012_10
